NEW MUST-SEE SOLUTIONS

OUR LATEST INNOVATIONS THAT
SERVICE PROFESSIONALS NEED TO KNOW ABOUT

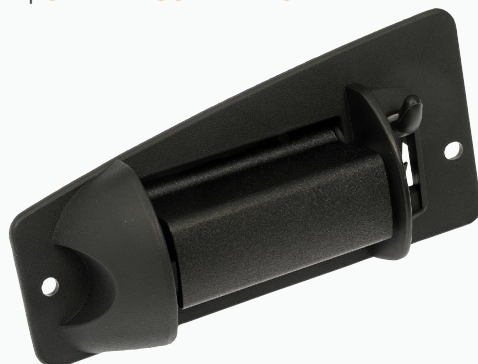
79100M (Rear Left)
Chevrolet 2007-00, GMC 2007-00

Metal Exterior Door Handle

The original exterior door handles on certain Chevy and GMC trucks often break because they're made of plastic.

This Dorman OE FIX replacement matches the fit and appearance of the factory handle but is upgraded with metal components for greater durability.

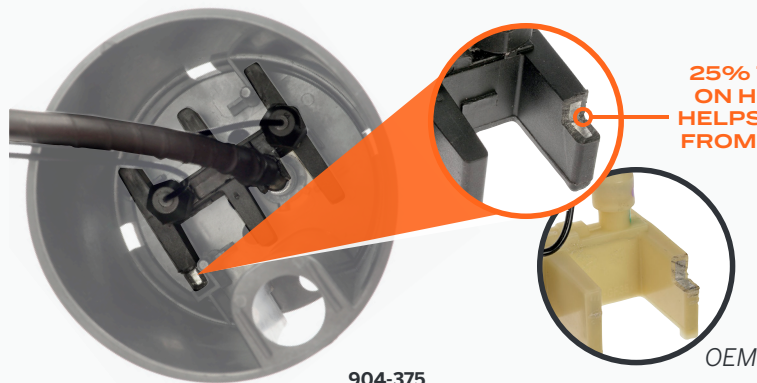
904-375
Mercedes-Benz 2015-07

Diesel Exhaust Fluid (DEF) Heater

**25% THICKER CASING
ON HEATER ELEMENT
HELPS REDUCE FAILURE
FROM FLUID INTRUSION**

The factory DEF heater element on certain Mercedes-Benz diesel engine-powered vehicles often fails from fluid intrusion.

Dorman's OE FIX DEF heater features a heater element casing that's 25% thicker than the original part to help reduce failure from fluid intrusion.

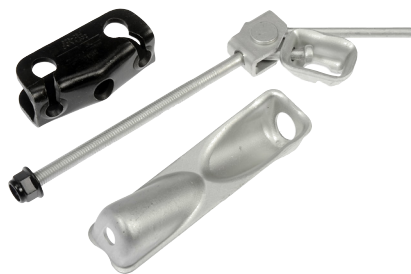
926-284

Parking Brake Cable Adjuster

- Direct replacement for the original equipment part that restores proper function to a corroded parking brake cable adjuster
- Must pass strict material and torque testing to ensure durable service
- Enables parking brake operation by equalizing cable tension

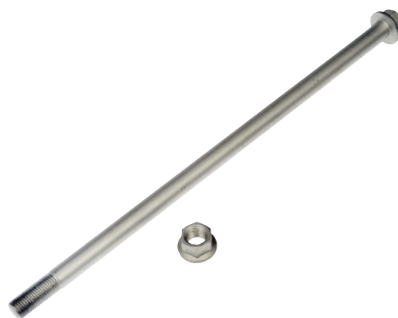
926-339

Control Arm Bolt

- This replacement upper control arm bolt simplifies suspension repairs when the original control arm bolt is corroded, stripped or broken
- Hardened steel construction that matches the fit and function of the original bolt
- Has undergone material testing and validation to ensure reliable service life

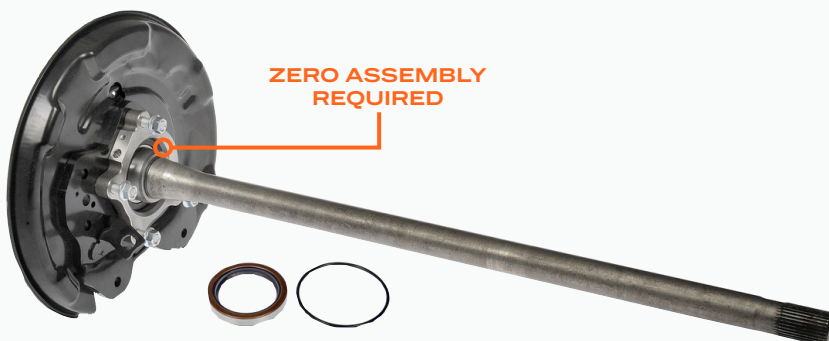
926-143 (Rear Left) | 926-144 (Rear Right)
Toyota Tundra 2016-07 - V8 4.6L

Pre-Pressed Axles

On many late-model Toyota Tundra pickup trucks, without special equipment it's easy to damage the rear wheel bearing when pressing out the old bearing or pressing in the new one.

Dorman's OE FIX pre-pressed axles include all the major components needed for a complete repair, pre-assembled and ready to install right out of the box, with no shop press or specialized equipment required.

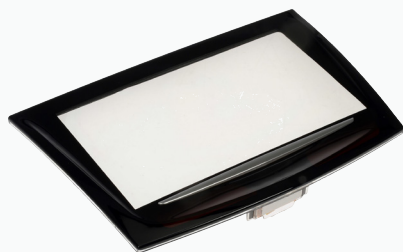
601-710

Infotainment Screen

When the infotainment touchscreen on certain CUE-equipped Cadillac models cracks and delaminates, the dealer only offers a complete infotainment module to fix it.

Dorman's OE FIX replacement screen allows the damaged screen to be replaced, rather than the entire module assembly.

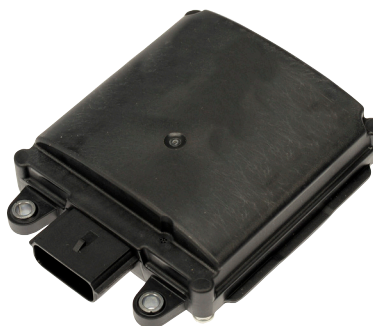
601-289

Blind Spot Module

- This aftermarket-exclusive blind spot detection (or object sensor) module is a reliable replacement for the original module that has failed due to damage or electrical malfunction
- Engineered to match the fit and function of the factory module on nearly a million late-model Ford and Lincoln vehicles in operation today
