NEW MUST-SEE SOLUTIONS

OUR LATEST INNOVATIONS THAT
SERVICE PROFESSIONALS NEED TO KNOW ABOUT

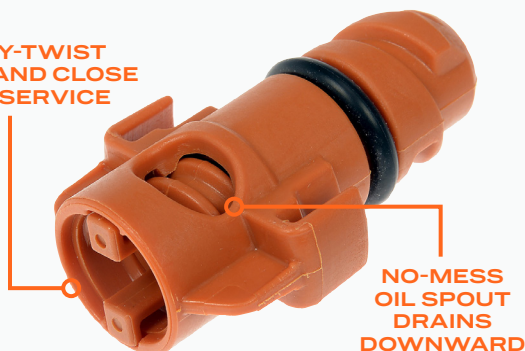
097-826HPD

Plastic Oil Drain Plug

**EASY-TWIST
OPEN AND CLOSE
FOR SERVICE**

**NO-MESS
OIL SPOUT
DRAINS
DOWNWARD**

Original equipment drain plugs on over 2 million late-model Ford and Lincoln vehicles cause oil splashing on chassis components during oil changes.

This Dorman OE FIX plug is made of high-temperature plastic and features a downward-facing drain hole and convenient twist tabs for easy, spill-free servicing.

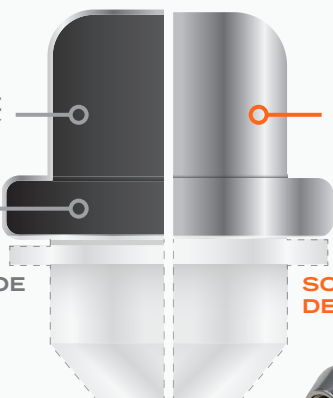
611-584

Wheel Nuts

**THIN DECORATIVE
OVERLAY**

STEEL WHEEL NUT

**SOLID CARBON STEEL
WITH CHROME FINISH**

**TWO-PIECE OE
DESIGN**

**SOLID OE FIX™
DESIGN**

The original lug nut on more than 1.5 million Ford Explorers and Police Interceptor Utility vehicles has a failure-prone two-piece design that makes rust common and repair difficult.

This Dorman OE FIX replacement has a one-piece, carbon steel design to prevent future problems.

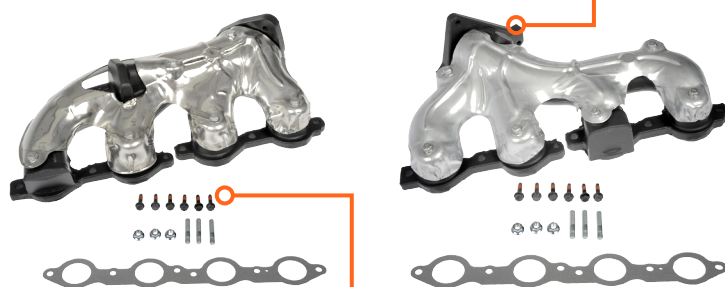
**SALT SPRAY TESTS ON
ORIGINAL EQUIPMENT EXHAUST
MANIFOLDS VS. DORMAN
CERAMIC-COATED MANIFOLDS.**

OE manifolds were rust-covered after just 24 hours. Dorman's ceramic-coated exhaust manifolds had less than 15 percent rust on surfaces after 72 hours.

- Dorman's heat- and corrosion-resistant, high-performance ceramic coating provides hardworking commercial fleets and work trucks a more durable solution for replacement exhaust manifolds
- Includes gaskets and hardware for a hassle-free installation on vehicles powered or repowered with General Motors LS engines
- First in Dorman's new ceramic-coated manifold lineup, with expanding coverage for many popular engines coming soon

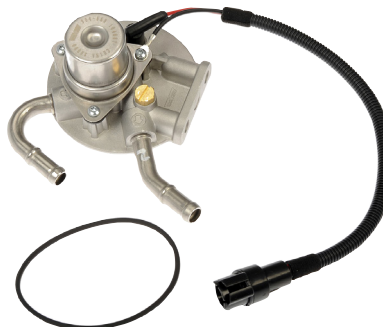
904-558

HD Diesel Fuel Filter Housing

- Ready to install with all necessary hardware for a complete repair
- Eliminates fuel leaks from a damaged coupling and fixes rough-start and no-start conditions
- Tested to ensure a trouble-free fit and installation

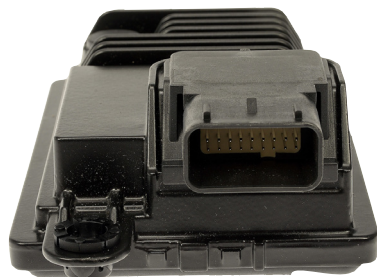
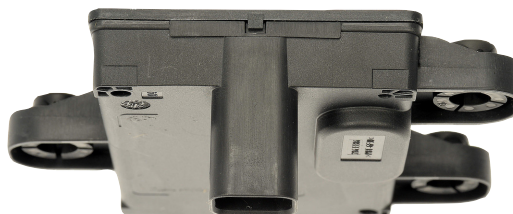
Cruise Control Distance Sensor

- Direct replacement for failure-prone factory sensor on over 3 million Ford and Lincoln pickups and SUVs
- Clears fault code and restores adaptive cruise control distance detection function to original equipment standards
